Candelaria Nature Preserve

Operational Activity

Winter Report FY 2023

Ciudad Soil and Water Conservation District

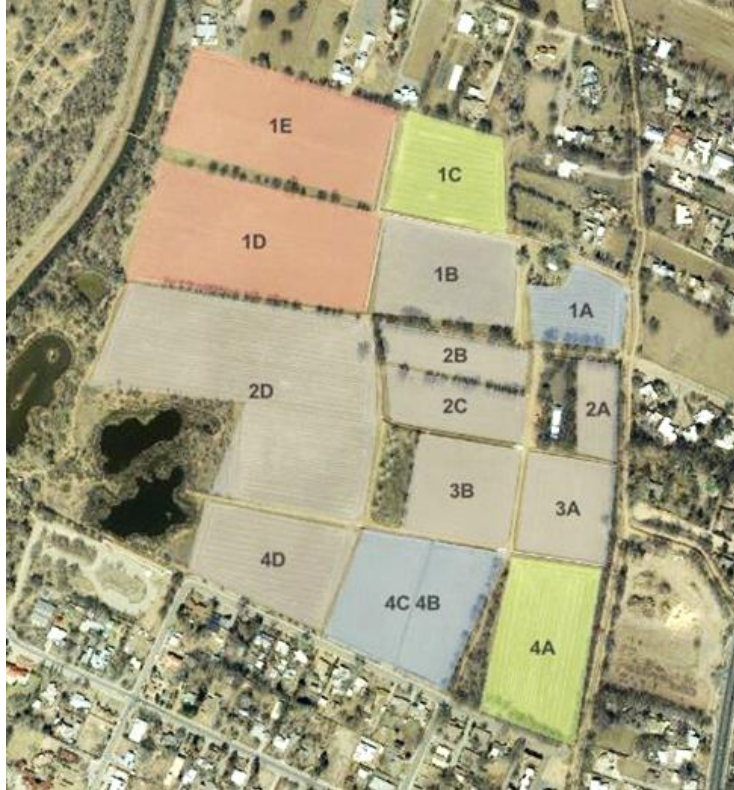
Figure 2. Designations of the different fields within the North Tract of land in the CNP perimeter. The RGNCSF is distinguished by the ponds in the middle-left portion of the photograph (from Candelaria Nature Preserve Operational Activity Winter Report FY, 2021).

The purpose of this report is to detail activities that have occurred on the North Tract of the CNP during the 2023 calendar year as outlined in the RMP. This report focuses on the activities that took place on the areas of land on the CNP that are leased to Ciudad SWCD. These activities occurred on the North Tract which totals 78.44 acres. (figure 2).

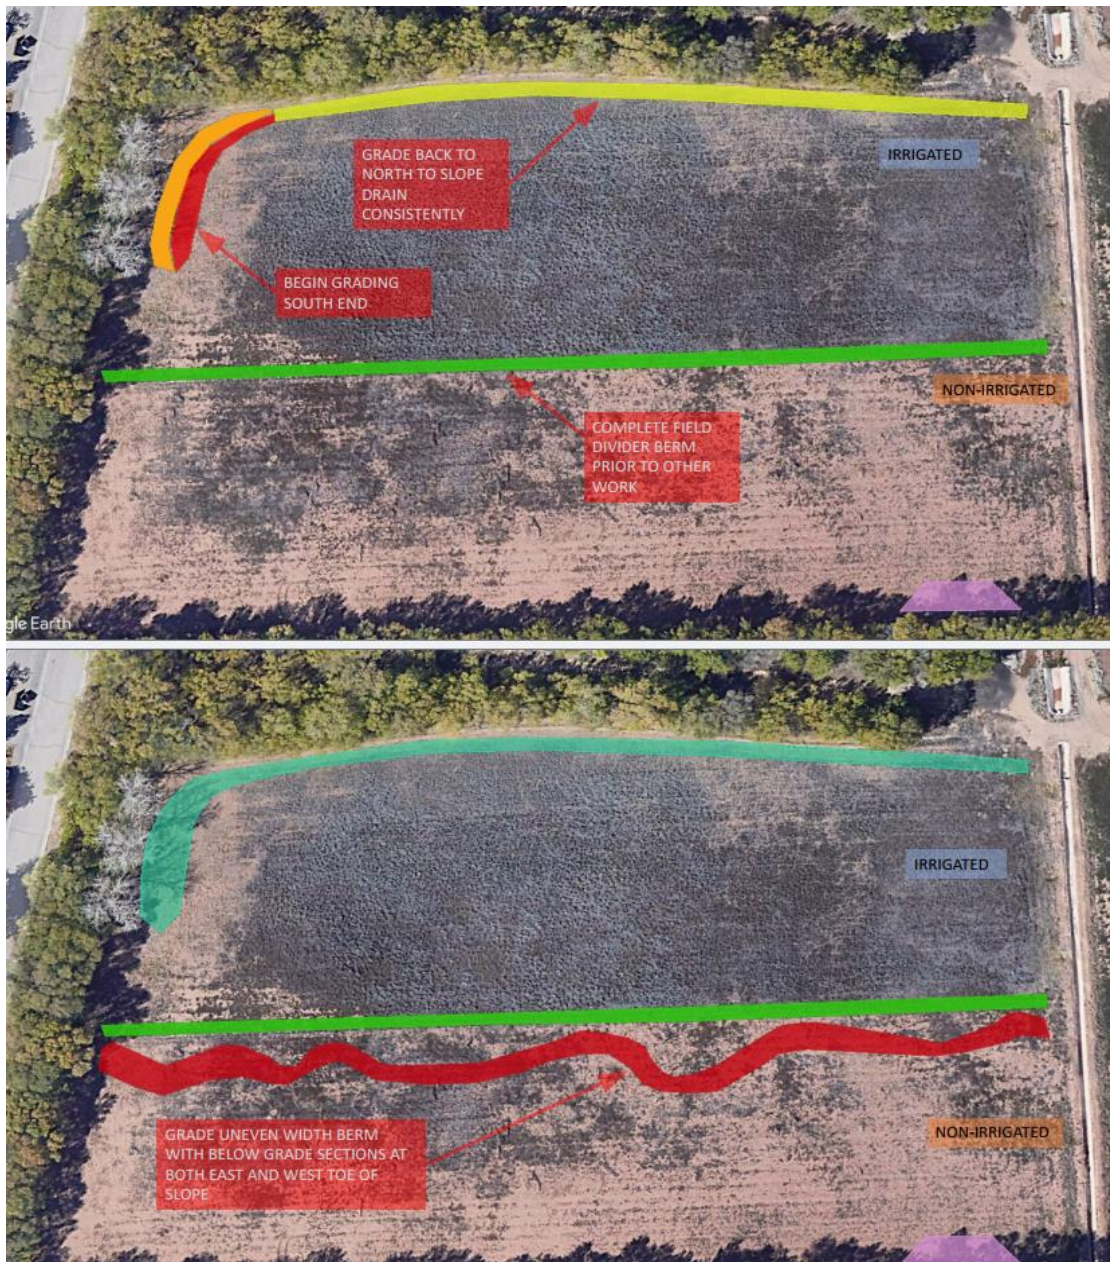
Figure 4. Design-plan schematic for field 4A developed by RGR and CSWCD. Top photo shows first phase of implementation, followed by the second stage in the bottom photo. North direction is approximately to the right of figure.

In Fall of 2023, Rio Grande Return (RGR) and Ciudad SWCD staff developed a habitat restoration plan for the eastern portion of Field 4A (approximately 7 acres of predominantly Gila Clay Loam soils). Although this portion of 4A is the primary viewing area for visitors to the eastern wildlife blind, the eastern portion also presents a challenge because there are no surface-water irrigation rights on this section of the field and water must therefore be brought in via pipe, hose, or other mechanical method. With that consideration, the habitat-design plan incorporates topographic changes that will simultaneously harvest rainwater, enhance shade, and provide wind protection to native-habitat, shrub-planting zones (figure 4).

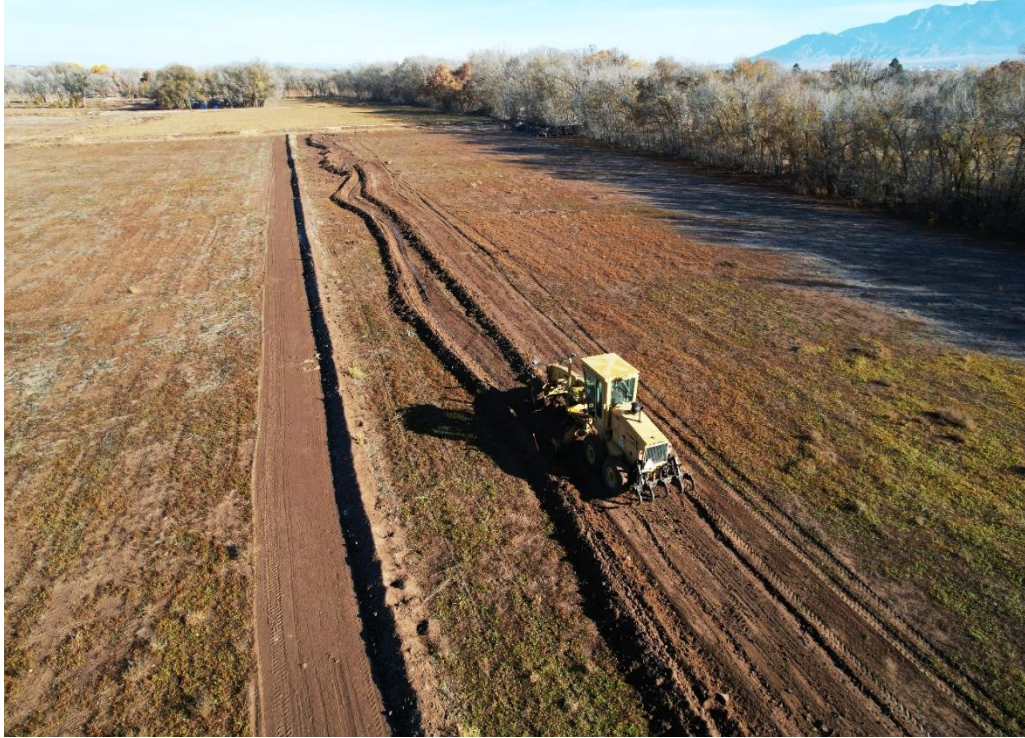
Figure 5. Grading of field 4A in Fall 2023. Top of photo is north direction.

Grading and construction of berms was completed in Fall 2023 (figure 5). In addition, native dryland grasses were no-till drilled into the open zones of 4A to allow establishment during precipitation events. No-till tillage, or conservation tillage, limits disturbance to the soil surface and allows composting of agricultural residue in place (OSD, 2021).

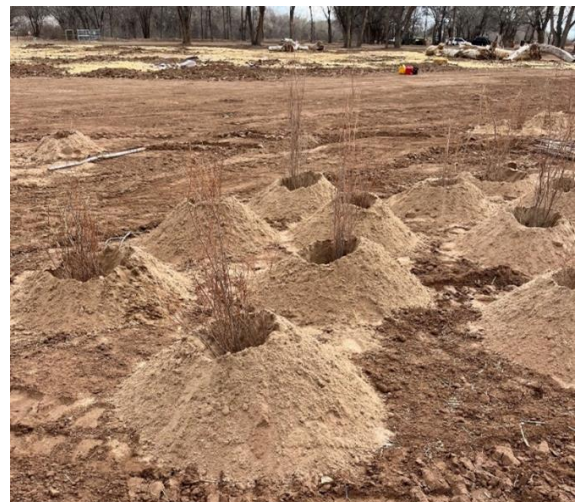
Figure 7. Auger holes and shrub plantings in CNP field 1A .

Lastly, CNP partners, with the help of volunteers, planted, mulched, watered and weeded hedgerow plants along Fields 1A and 1B (figure 7).

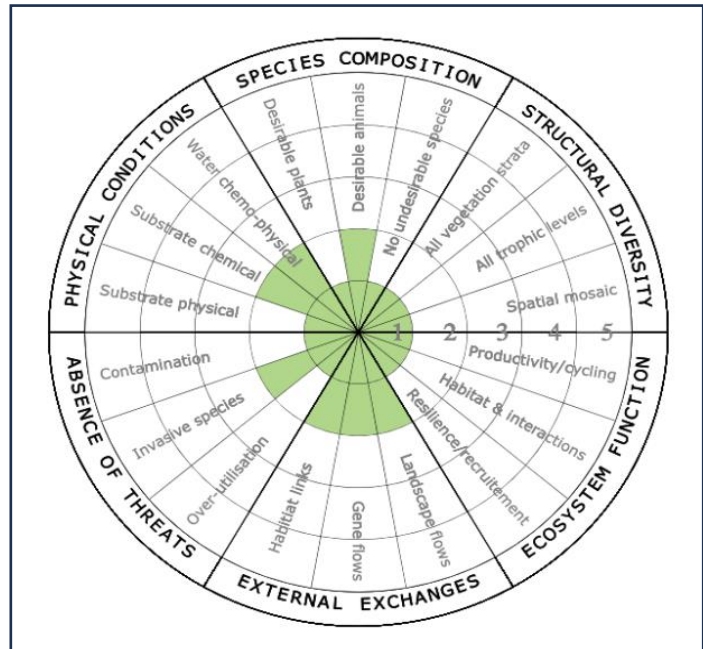
Figure 8. An example of a completed SER recovery wheel assessment. The wheel has been populated with actual information from the CNP in 2022 (from Candelaria Nature Preserve Operational Activity Winter Report FY, 2022).

All 18 sub-attribute scores can also be plotted in a circular, wheel-shaped diagram that provides a good visual reference for the relative state of recovery for the evaluated ecosystem; this diagram is the actual SER recovery wheel (fig. 8).
